Discussion of the current condition and proposed next steps for Turners Creek Granary:

**GREDELL
& ASSOCIATES**
STRUCTURAL ENGINEERS

March 23, 2009

WO 2810
STRUCTURAL CONDITION ASSESSMENT
THE GRANARY
TURNER'S CREEK PUBLIC LANDING
KENNEDYVILLE, MARYLAND

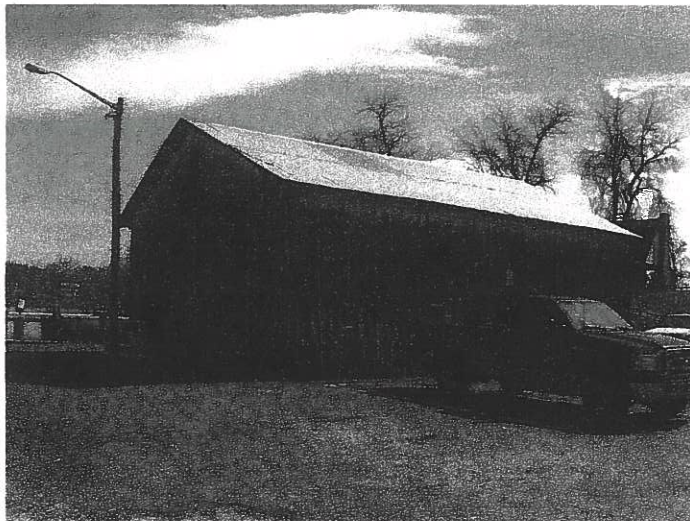
*The Granary, Turner's Creek Public Landing, Northwest Elevation
Gredell & Associates 12 March 2009*

We have completed our review of The Granary at Turner's Creek Public Landing. The review consisted of visual observations and selective probing of those portions of the structure which were safely accessible during our visit on 12 March 2009. The request for this study was prompted by concerns regarding the structural stability of the building; in particular, at the first floor/ground level where damage from rot and termite infestation is extensive. The primary purpose of this report is to determine the scope of work to stabilize, preserve and eventually restore the building structure. In addition, we have determined allowable floor and roof loading as input for your consideration of uses of the building that are compatible with the building structure. To assist the reader with the orientation of the structural elements discussed, we have provided framing plans with superimposed structural grid lines. For orientation purposes we have assumed that the entrance to the corridor is located on the south side of the building facing the access road.

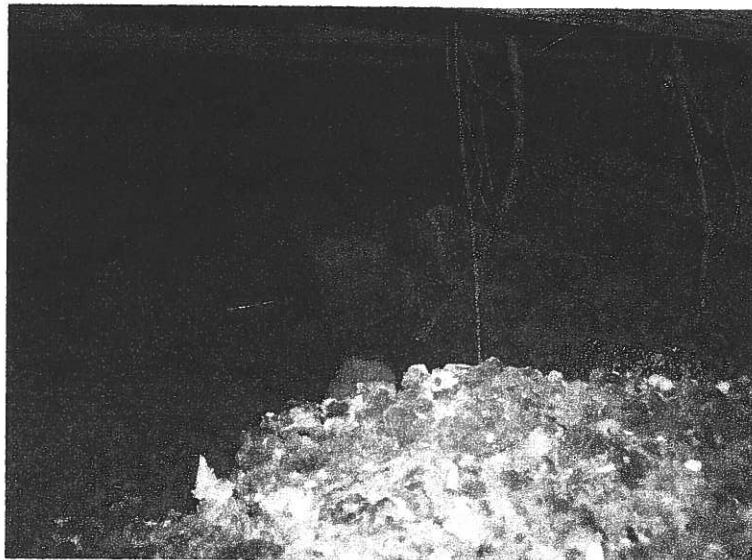
The foundations for the building are constructed of uncoursed stone rubble masonry approximately 20" wide that run east west as shown on the attached sketch 1 of 4. The foundations are in poor condition with the structural matrix of the mortar reduced to sand. As a result the stones in the wall are loose and the section has become unraveled and subsiding. At the north wall "A" the foundation has been rebuilt with cast-in-place concrete.

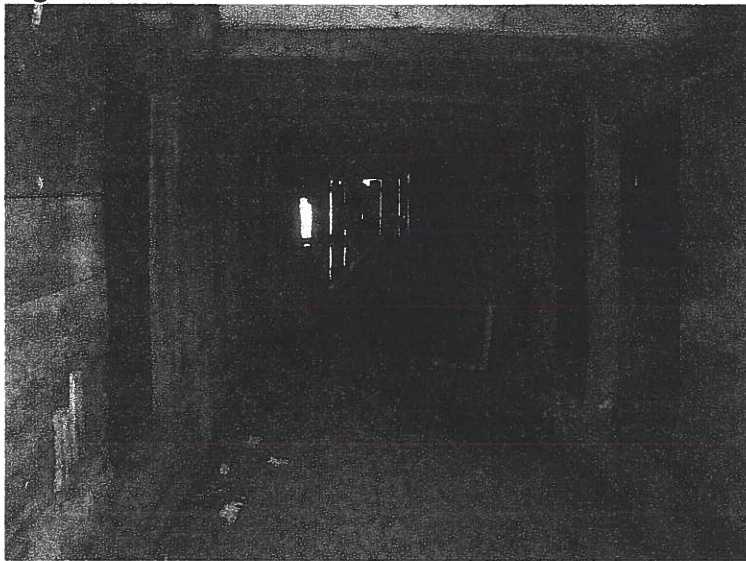
The timber framing in the building rests on heavy timber sills (east-west) that bear on the rubble stone masonry foundation walls and timber girders (north-south) that support the interior heavy timber posts that form the central corridor of the granary. The poor condition of the masonry foundations coupled with the rot and termite damage in and above the crawl space (see photograph above) has caused the building to subside as much as 8" as witnessed by the "humping" of the floor in the central corridor. The total extent of the termite damage is

unknown; however, it extends at least 3' above the first floor level at the exterior posts, girts and bracing. Weakening of the second floor beam at C2 is witnessed by a tension crack at a beam splice with evidence of previous damage caused by infestation. At the northwest corner "A1" the entire post has been consumed by rot and termite damage along with beams, girts and bracing that are joined. The framing at each level of the building is described as follows:

Due to the extent of the deterioration in the framing at the lower, first floor, there appears to be no feasible method of temporarily stabilizing the structure at that level. Instead, we recommend the building be stabilized by providing temporary support at the second level. Provide structural needle beams (east-west) adjacent to the five bents (three interior and two exterior) that span approximately 40' and supported by structural transfer beams (north-south) set on timber crib shoring towers. Transfer of the dead load of the building would be achieved by jacking to the desired elevation in combination with blocking.

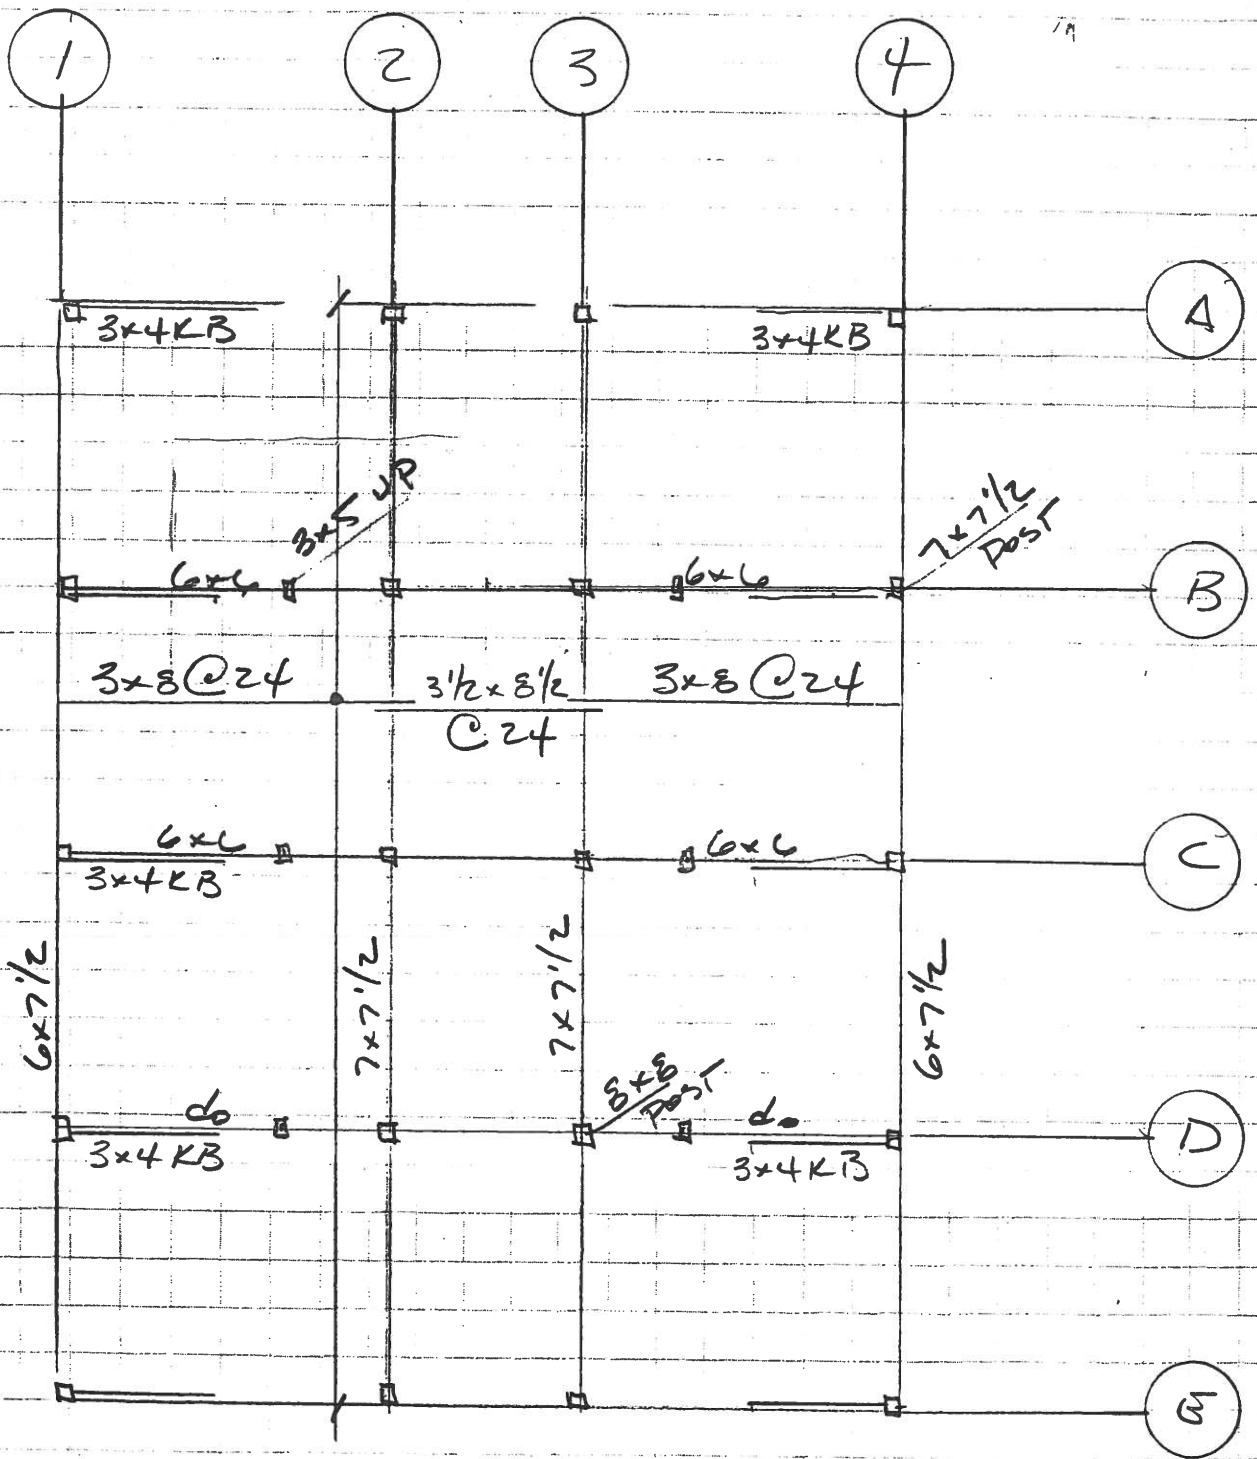
SECOND FLOOR FRAMING
1/8" = 1'-0"

- The second floor is framed with 3x8@24" joists spanning east-west and bearing on timber beams 7x8 ("2", "3") and 6x8 ("1", "4"). Except for the deterioration that has occurred at the northwest corner of the building adjacent to post "A1", the structural condition of the second floor framing appears good.

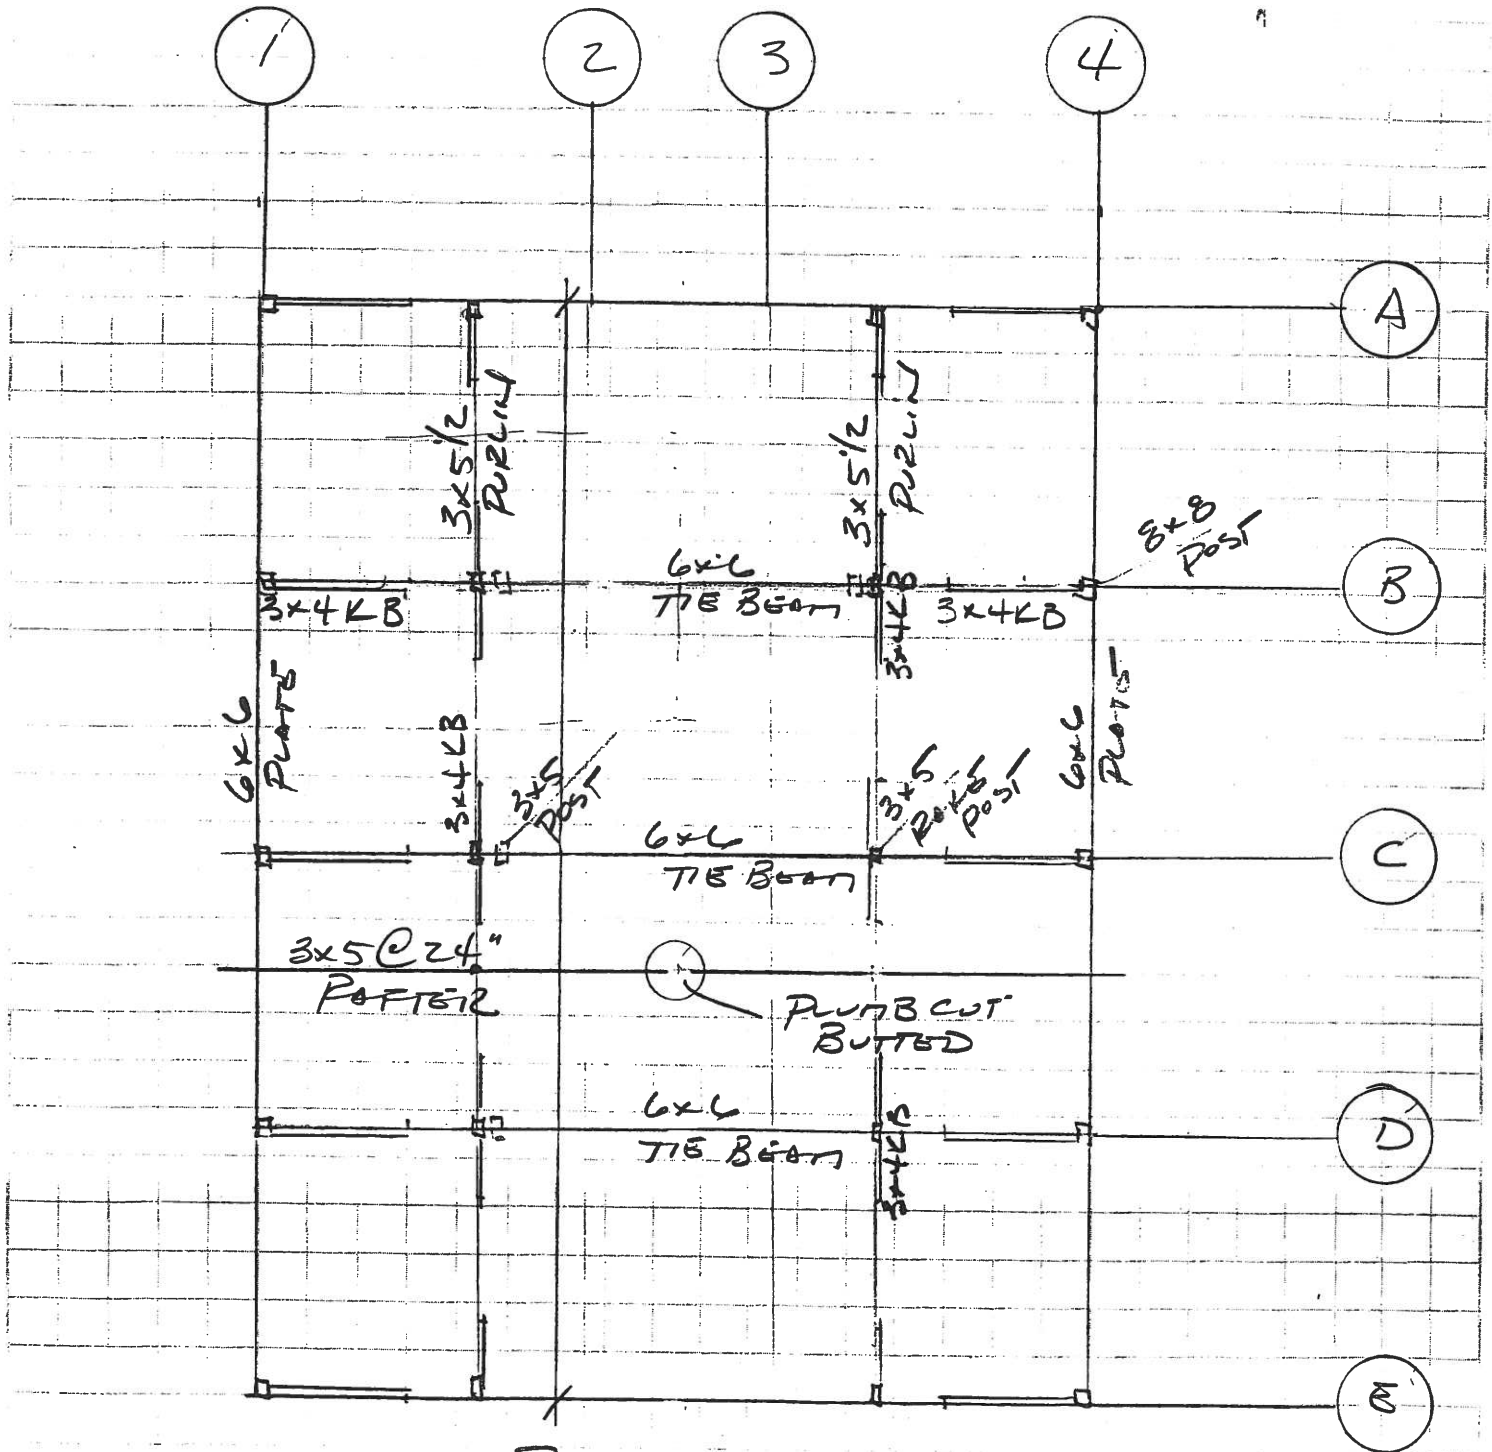
ROOF FRAMING
1/8" = 1'-0"

- The primary structure of the gable form roof is comprised of 3x5 1/2 timber purlins spanning north-south and 3x5 rake posts set on 6x6 tie beams located at the three interior bent locations. The roof loads are transferred to the second floor 6x6 tie beams at the second floor with 3x5 posts located near the rake posts that support the purlins. Knee bracing 3x4 1/2 provides lateral stability for the structure. Rafters 3x5@24" overframe the purlin and the eave beam. At the ridge the rafters are plumb cut and meet with a simple butted joint. Purlin splicing is

achieved with half lap, pinioned scarf joints made adjacent to the knee bracing. The structural condition of the roof appears fair to good.

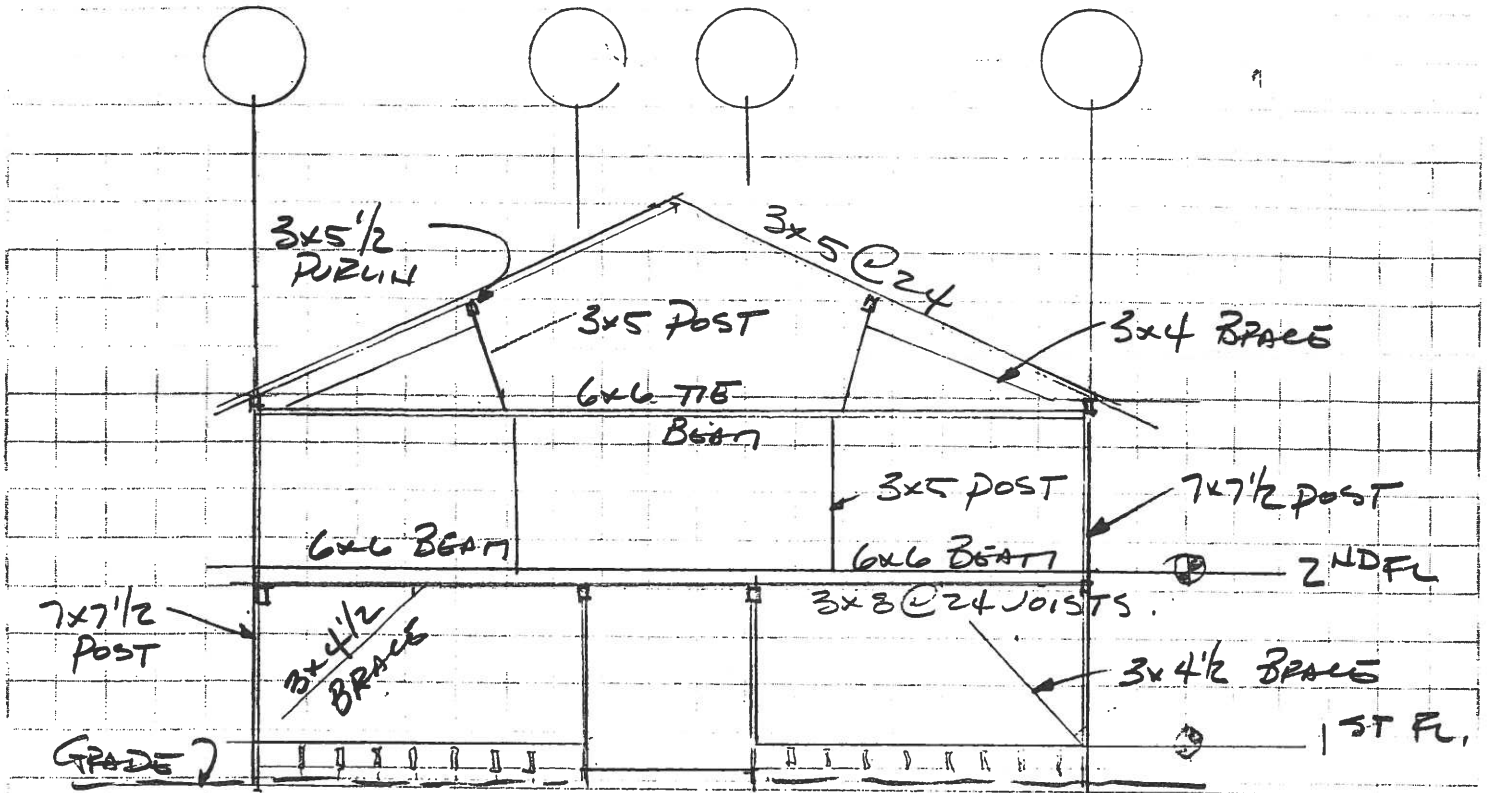
Section
1/8" = 1'-0"

- Lateral bracing north-south is provided by knee bracing at first and second floor levels on the east and west exterior walls as indicated by the elevation shown on sketch 4 of 4. Mortise and tenon joinery was observed at all bracing connections.
